# Manhole Inspection Summary

Manhole # S41CC\_037MH

Insp Date: **8/31/09 3:01 PM**

**Location** Address: **1409 EAGER ST**

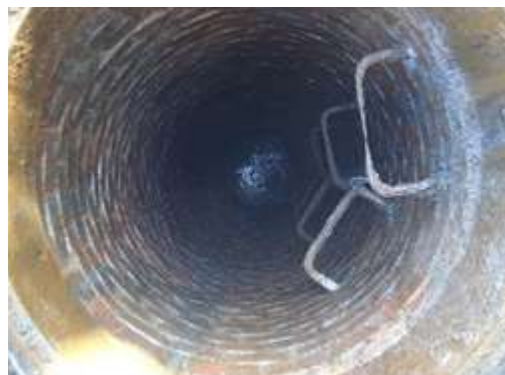
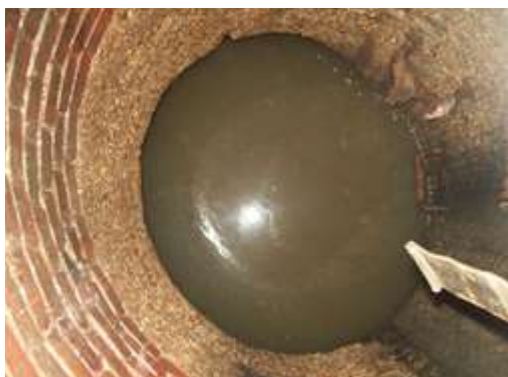
Top View

Comments **ACTIVE SPLASH/ DROP. CHANNEL TOO BIG FOR TOP VIEW PHOTO WITH PIPE CONNECTIONS**

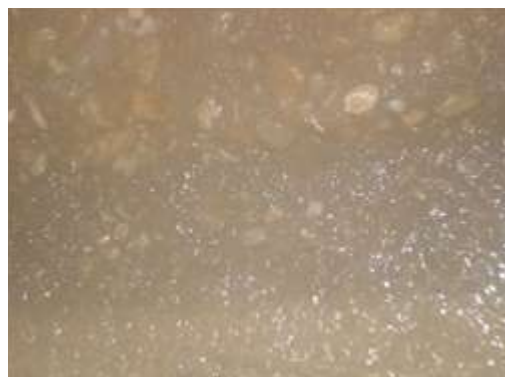
Defect 1

Condition: ☐ Sound ☒ **Cracked** ☐ Root Intrusion ☐ Loose Brick ☐ Deteriorated

1/4 TO 1/2IN CRACK IN CHIMNEY

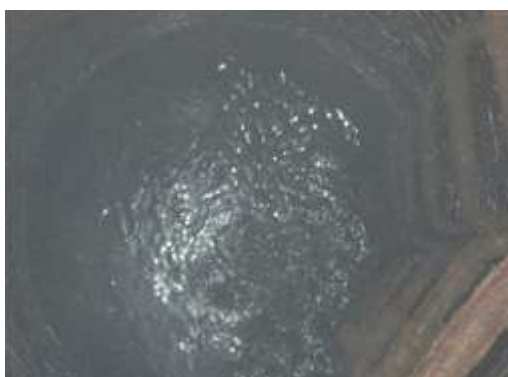
Defect 2

Count: **20** Missing: **0** ☒ **Corroded**

STEPS CORRODED

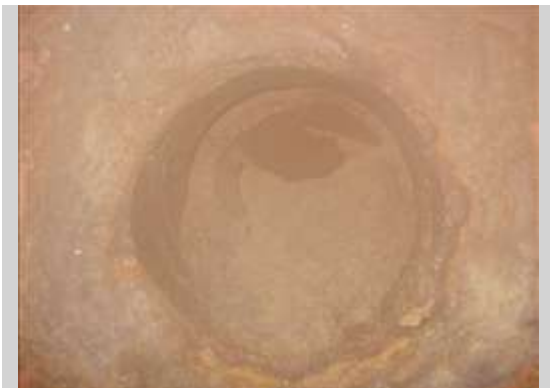
1 O'Clock Inflow

8 in. Circular Gravity Sewer  
Pipe In @ 1 O'Clock

Pipe Height: (in.) Direct  
Pipe Material: **Clay** ☐ Pipe Lined  
Invert Depth: **9.04** (ft.) Flow Characteristics: **None**  
Deposits: ☐ None ☐ Mud ☐ Sludge ☒ **Debris** ☐ Grease  
Silt Depth: **3** (in.) Deposits Extent: **Heavy**  
Infiltration: **None** Pipe Seal Cond: **Sound**

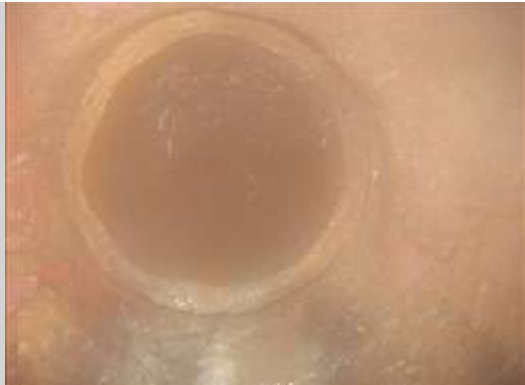
5 O'Clock Inflow

6 in. Circular Gravity Sewer

Pipe Seal Cond: **Broken**
